Historic Structures Report
Architectural & Historical Data Section

Clubhouse, Brown Cottage, Moorhead Cottage,
and Clubhouse Annex

**SOUTH FORK FISHING
& HUNTING CLUB**

By
Landmarks Design Associates, Architects
and
Wallace, Roberts & Todd

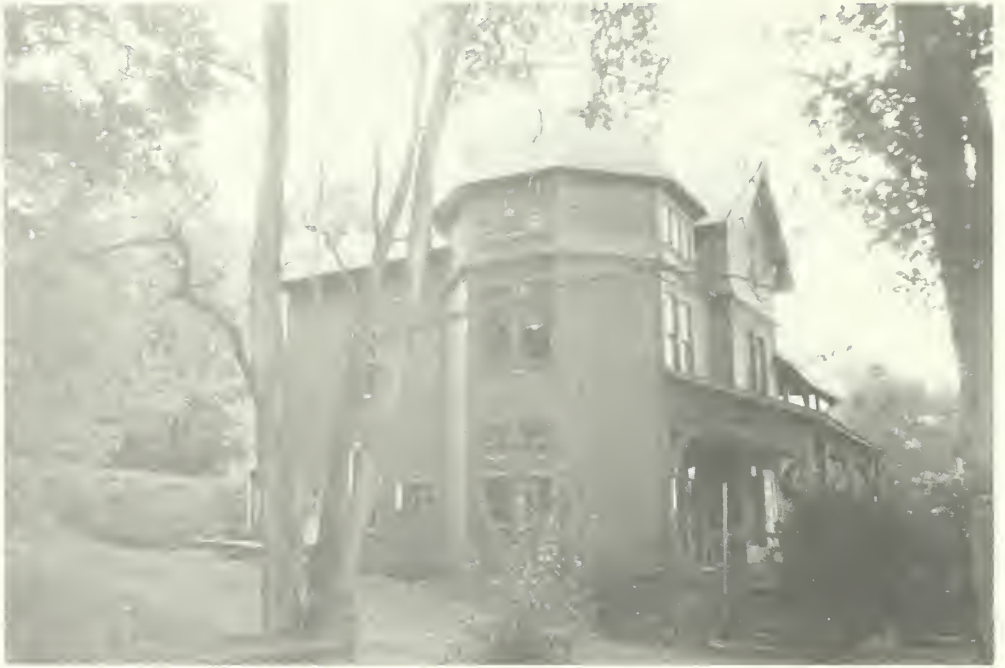
Photo E-1 South elevation of Cottage No. 3 (Moorhead).
1992

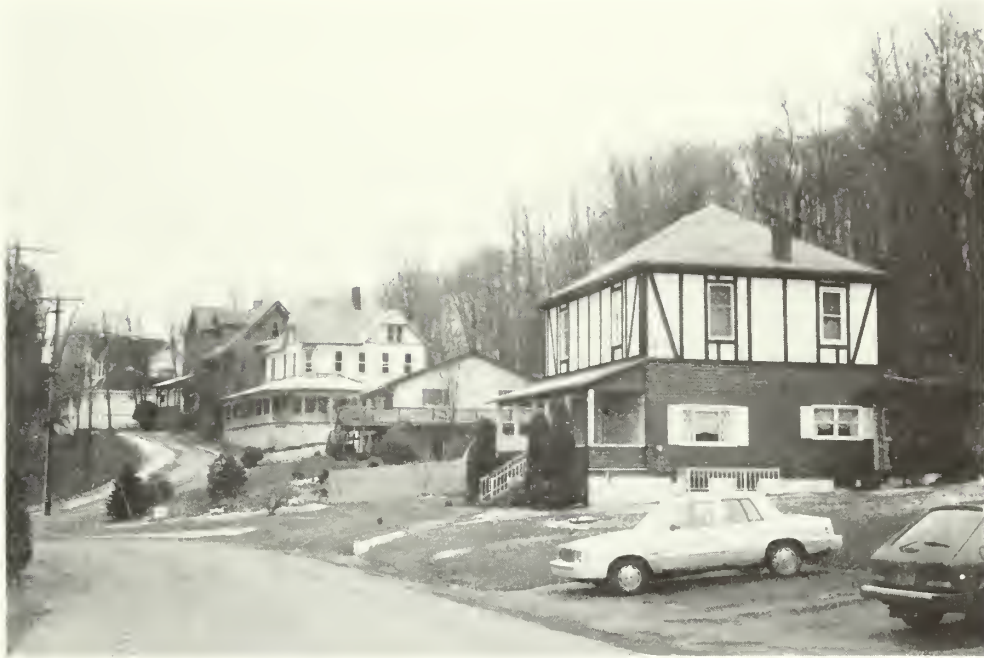
Photo E-3 Looking south past the heavily remodeled Cottage No. 6 in the foreground, and the site of Cottage No. 5, to Cottages Nos. 4, 3, and 2 in the background.
1992

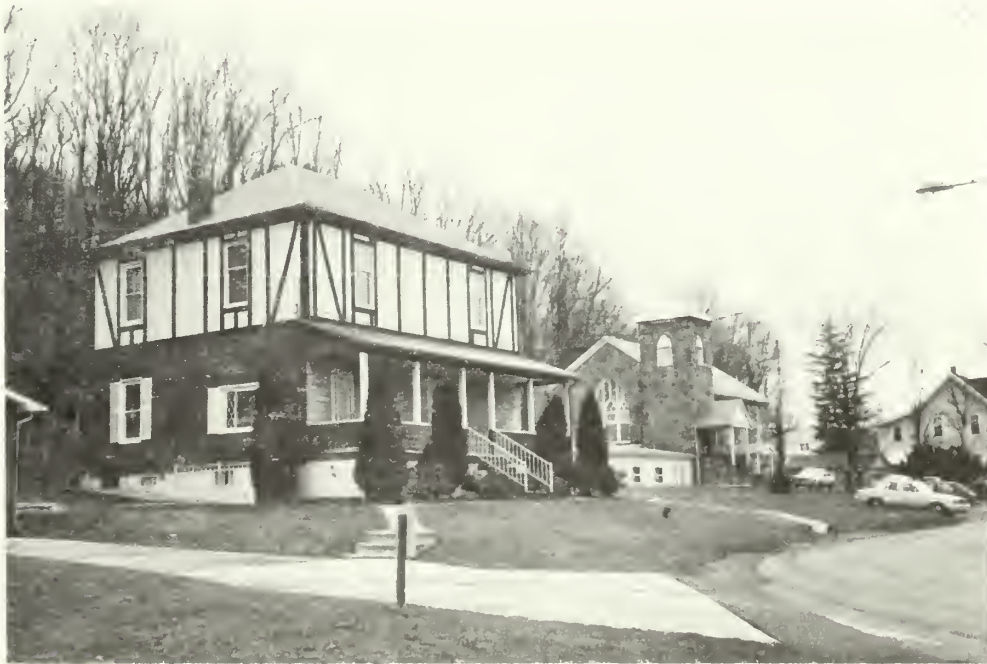
Photo E-4 Looking north past Cottage No. 6 in the foreground to the church on the site of Cottages No. 7 and 8. Cottage No. 9 is partially visible to the right of the photograph.
1992

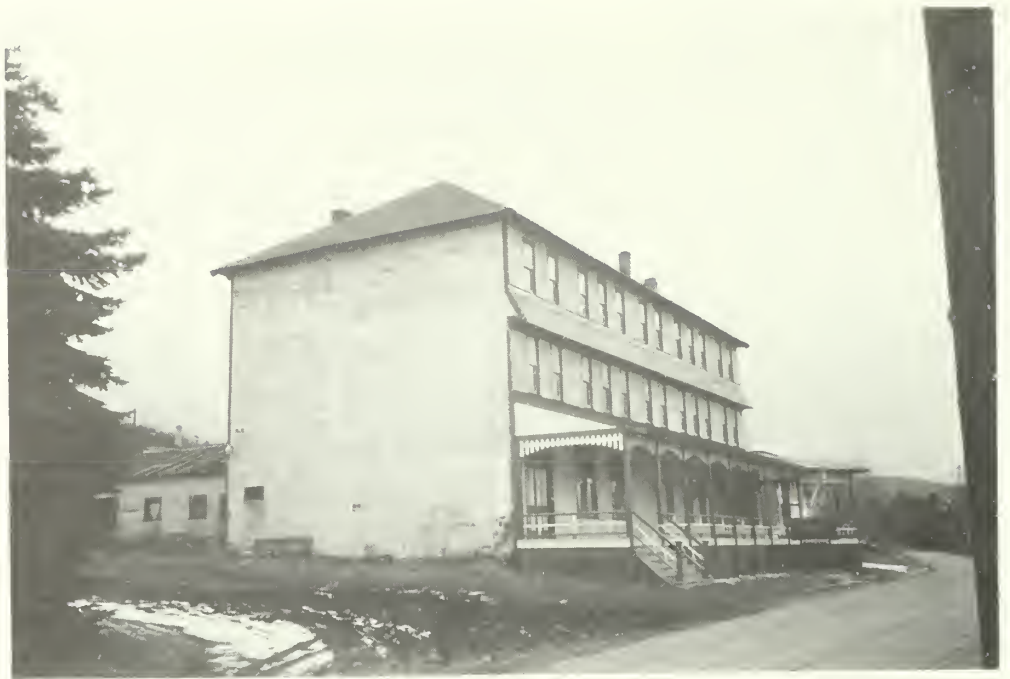
The building is a wood framed structure with a central double row of steel columns and support beams resting on a stone foundation and piers.⁷ More recent frame additions have been constructed at the southwest corner. (Photos E-9 through E-12)

Photo E-9 View of east and south elevations.
Clubhouse 1992

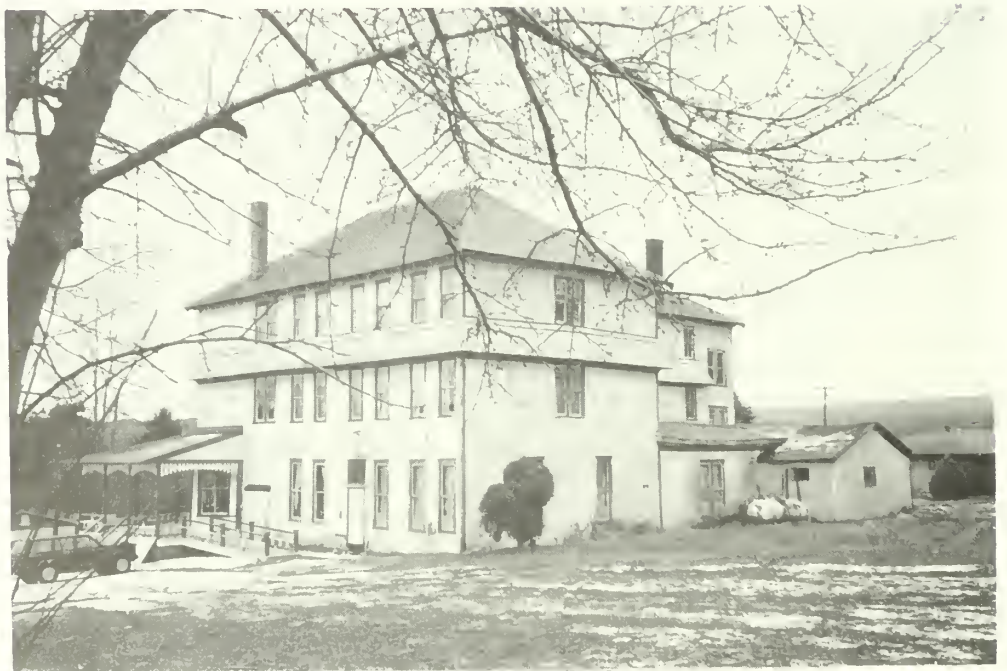
Photo E-10 View of north and west elevations.
Clubhouse 1992

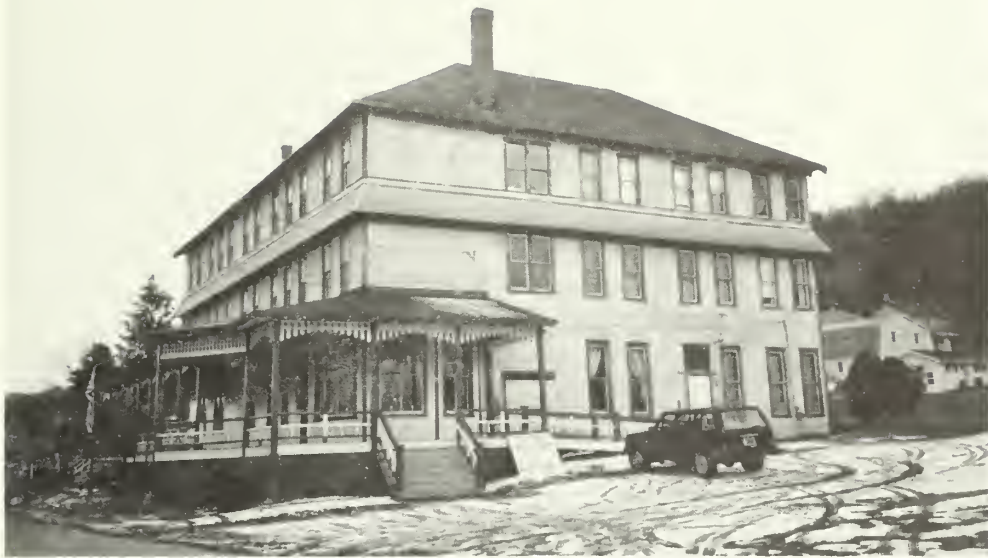
E-11 View of east and north elevations.
Clubhouse 1992

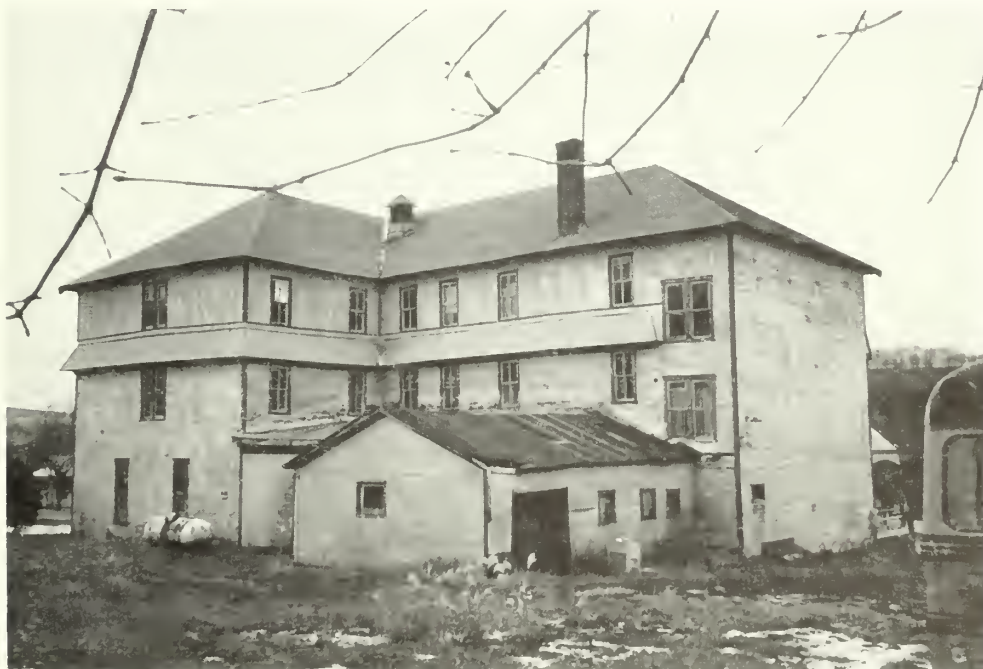
E-12 View of west and south elevations.
Clubhouse 1992

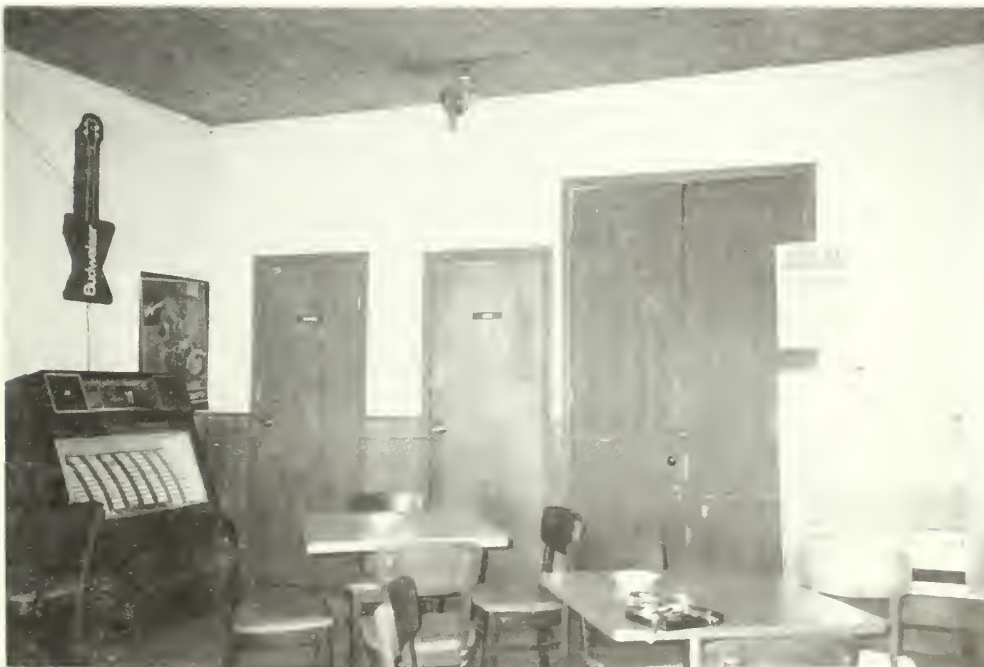
c E-15 West wall of room 102. Although the wall is new, the double doors are original and have been relocated.
Clubhouse 1992

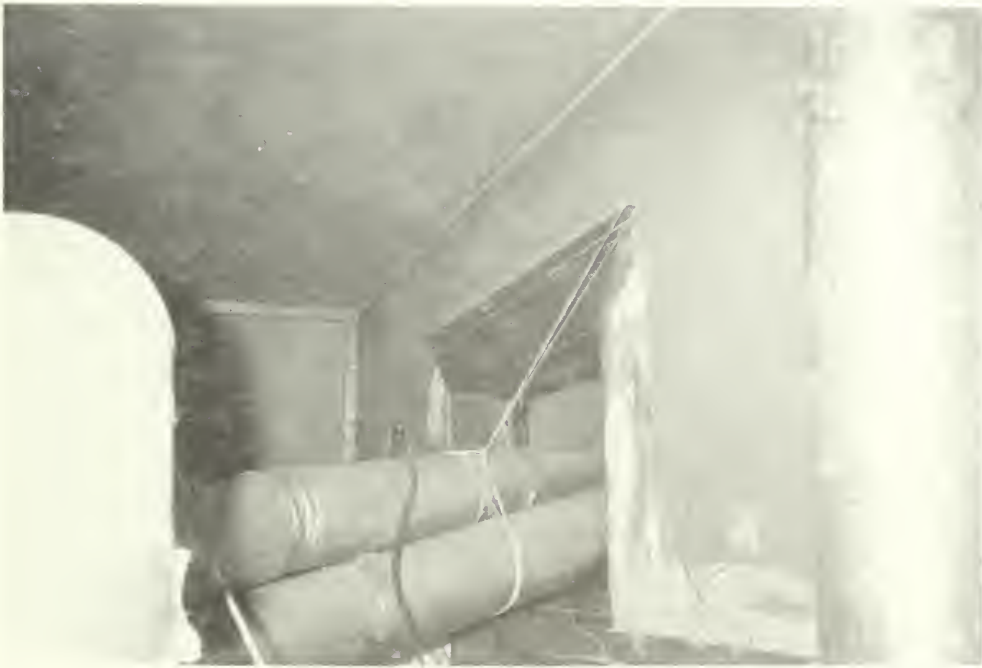
E-18 View above existing kitchen ceiling of room 107, looking northeast at east wall of original center hall and door opening.
Clubhouse 1992

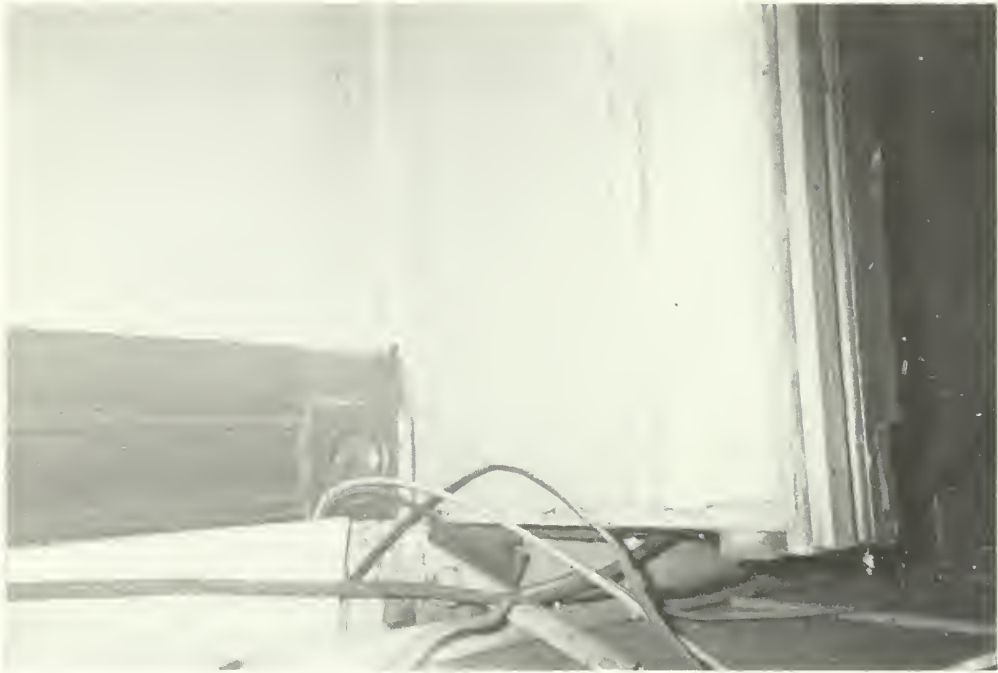
Photo E-19 View looking southwest above existing ceiling in room 107, showing original hall wall and upper part of door which once connected room to west. The door trim with the rose blocks in the south wall is later. Clubhouse 1992

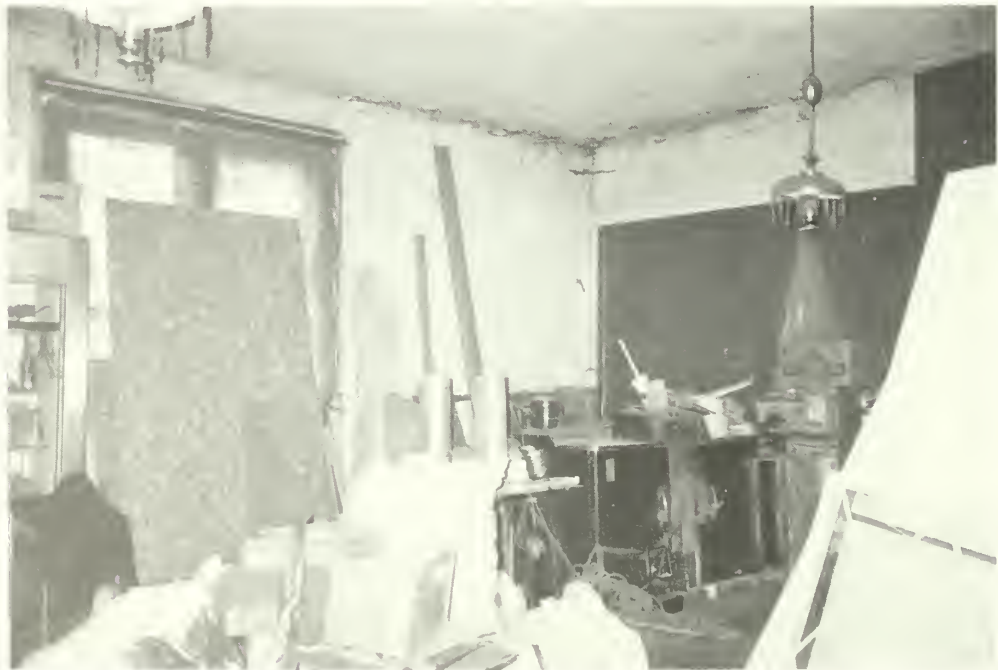
Photo E-20 Looking northwest in room 114 towards window in west wall and newer, large cased opening in north wall. Clubhouse 1992

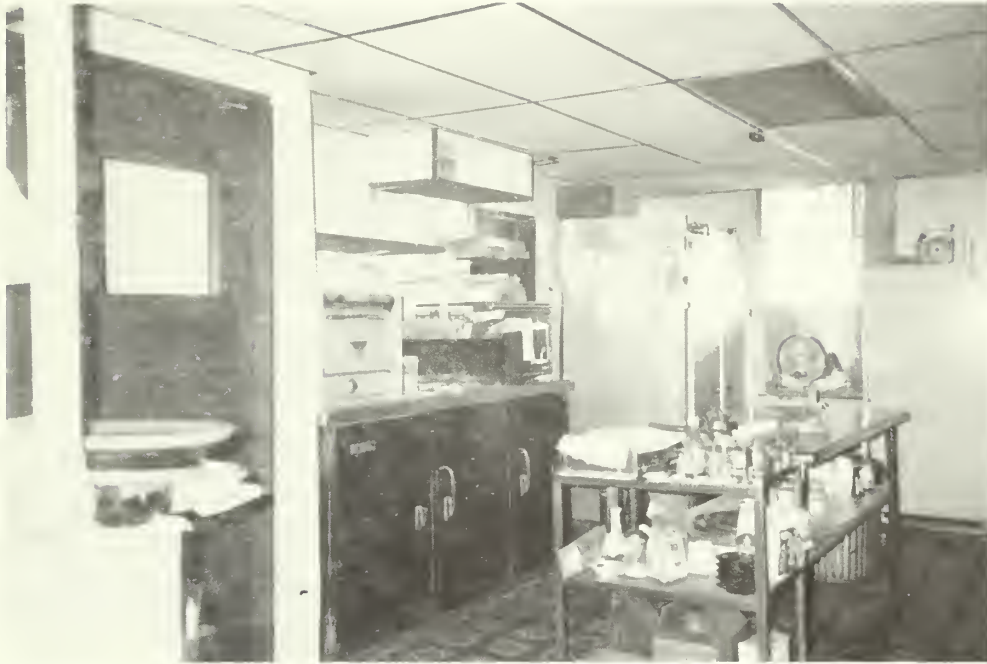
to E-21 Existing first floor kitchen in room 107, looking northeast.
Clubhouse 1992

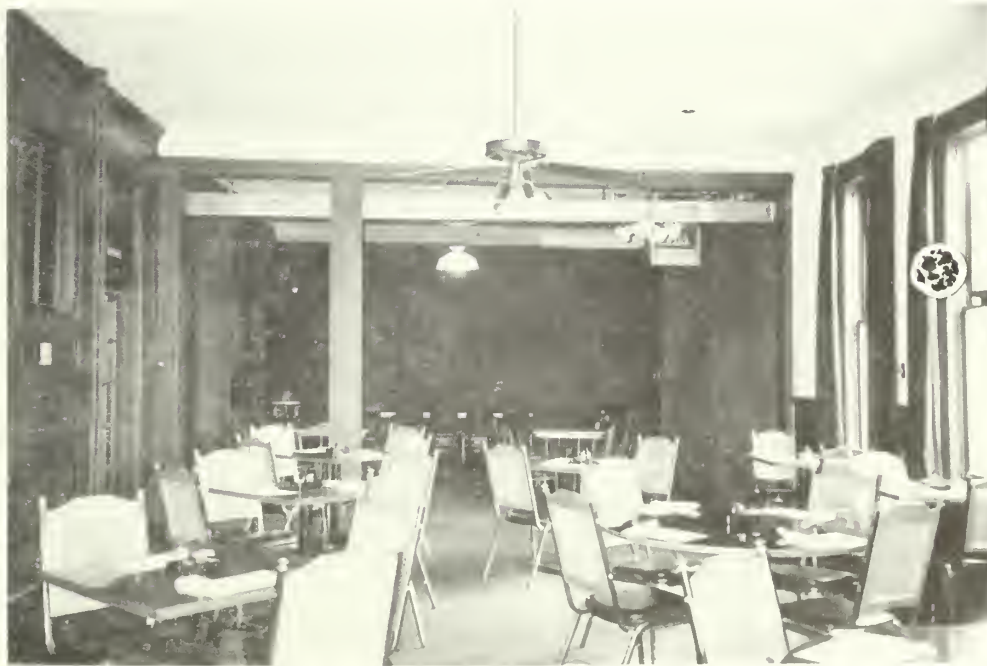
to E-22 Looking west from room 109 into room 113. The off-centered column was
originally enclosed in a wall dividing these two rooms.
Clubhouse 1992.

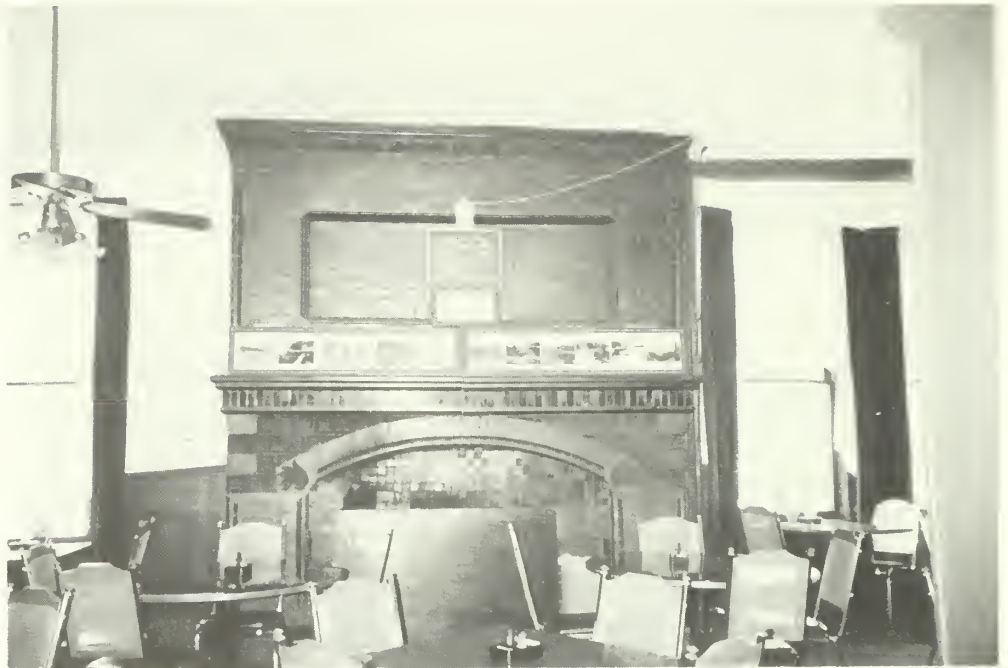
Photo E-23 View of fireplace and chimney on north wall of room 109.
Clubhouse 1992

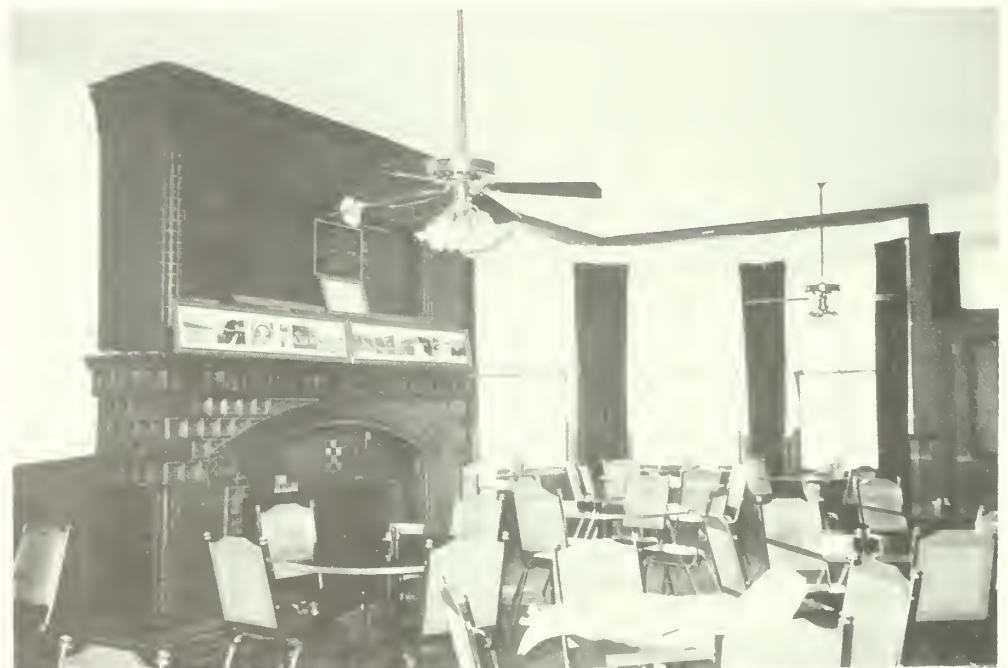
Photo E-24 View of northeast bay window in room 109.
Clubhouse 1992

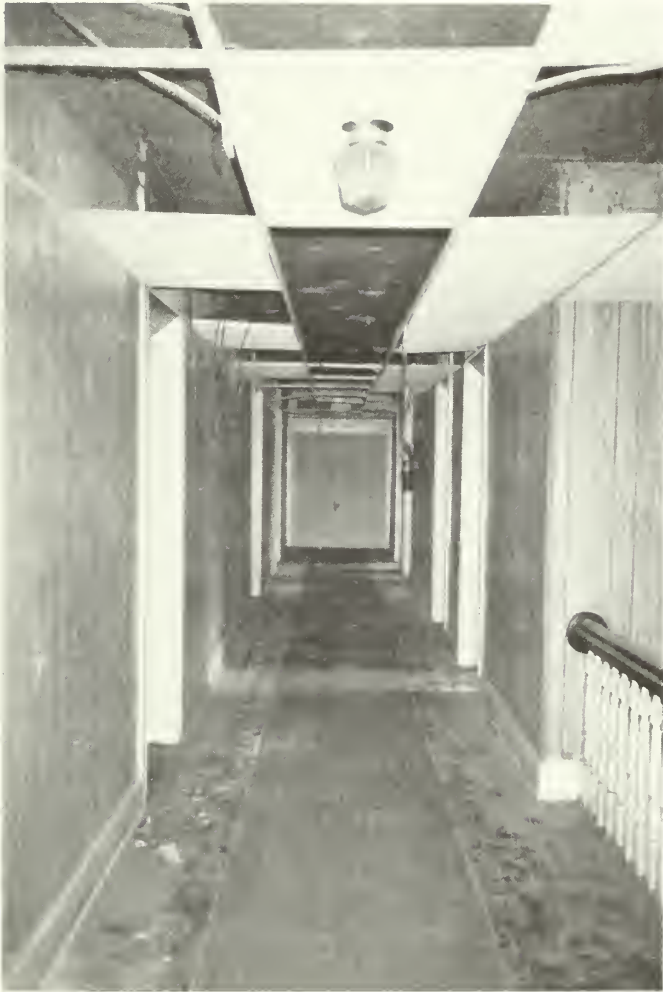
Photo E-25 Second floor hall, looking south. Note railing for main stair at right of photo.
Clubhouse 1992

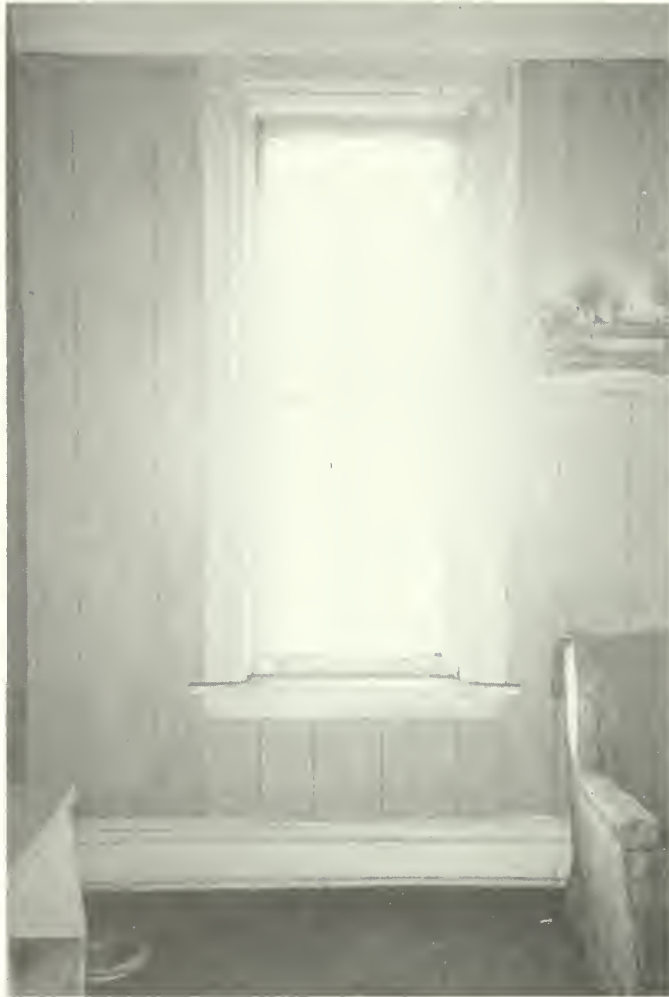
Photo E-26 Typical second and third floor baseboard and window trim.
Clubhouse 1992

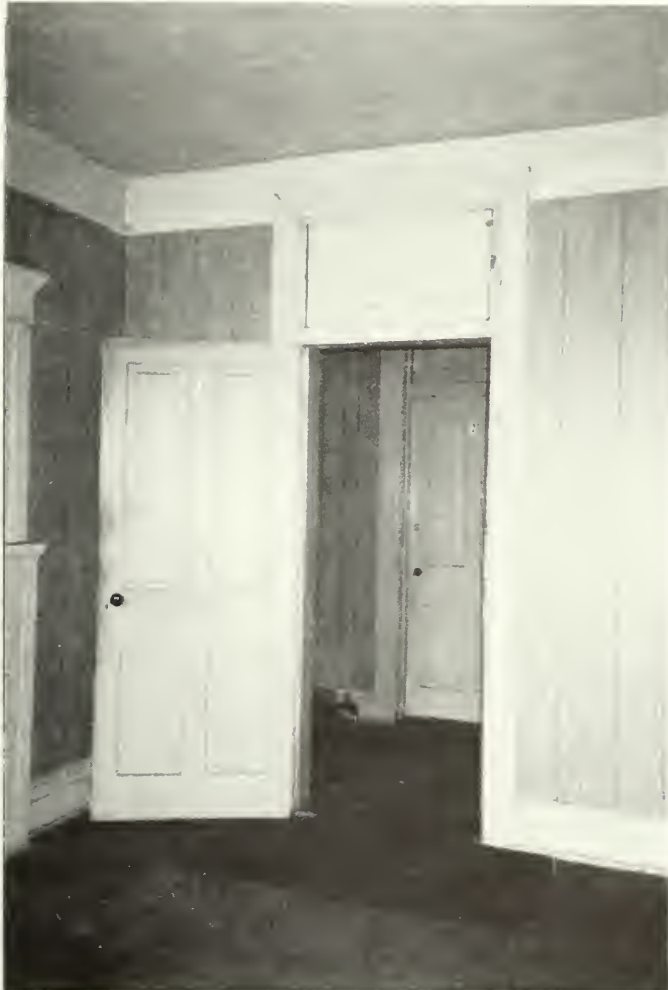
Photo E-27 Typical door and transom at second and third floor guest rooms.
Clubhouse 1992

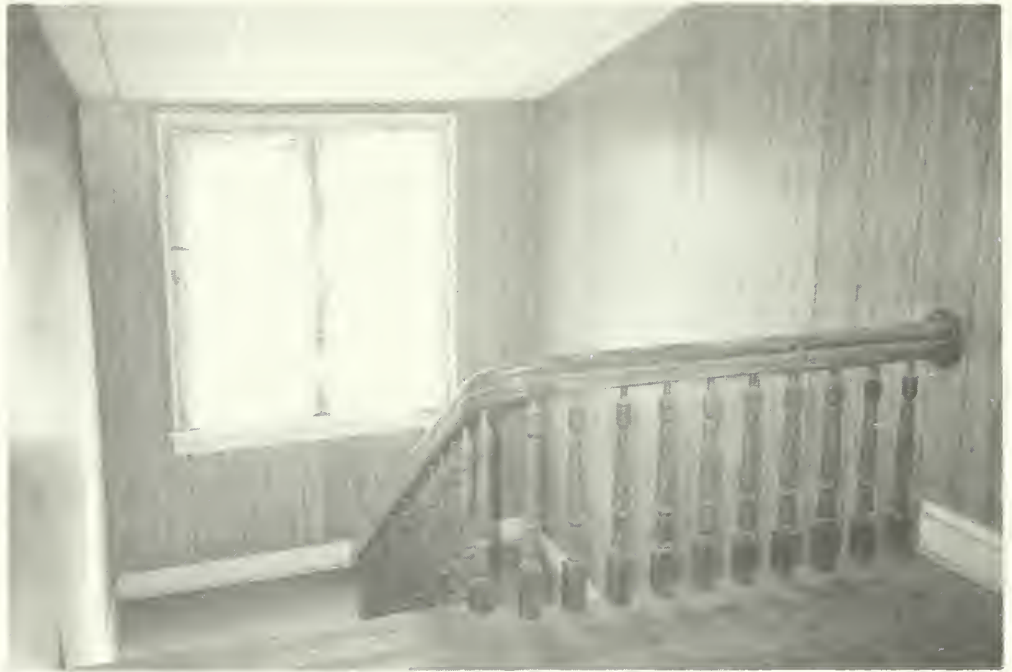
Photo E-28 View of south stair from third floor looking west.
Clubhouse 1992

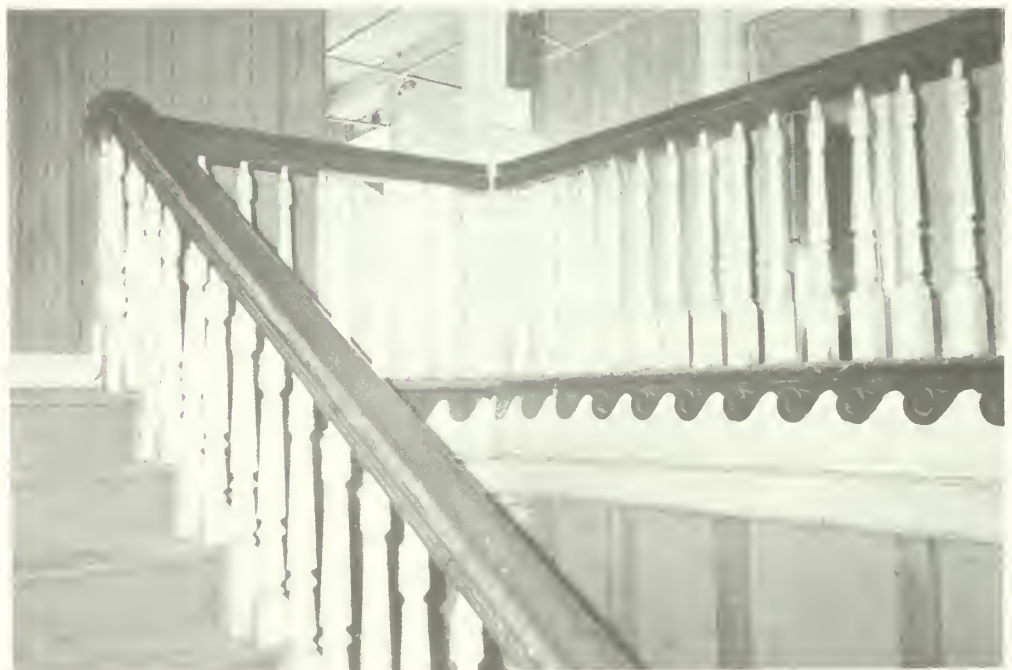
Photo E-29 View of north (main) stair from third floor looking north.
Clubhouse 1992

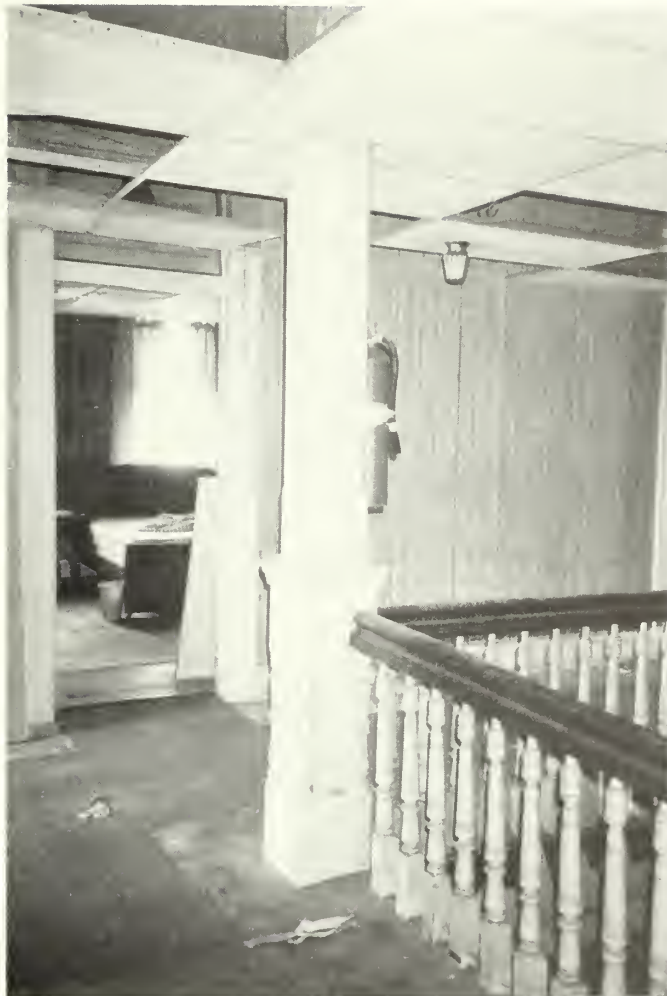
Photo E-30 Third floor hall and main stair looking east.
Clubhouse 1992

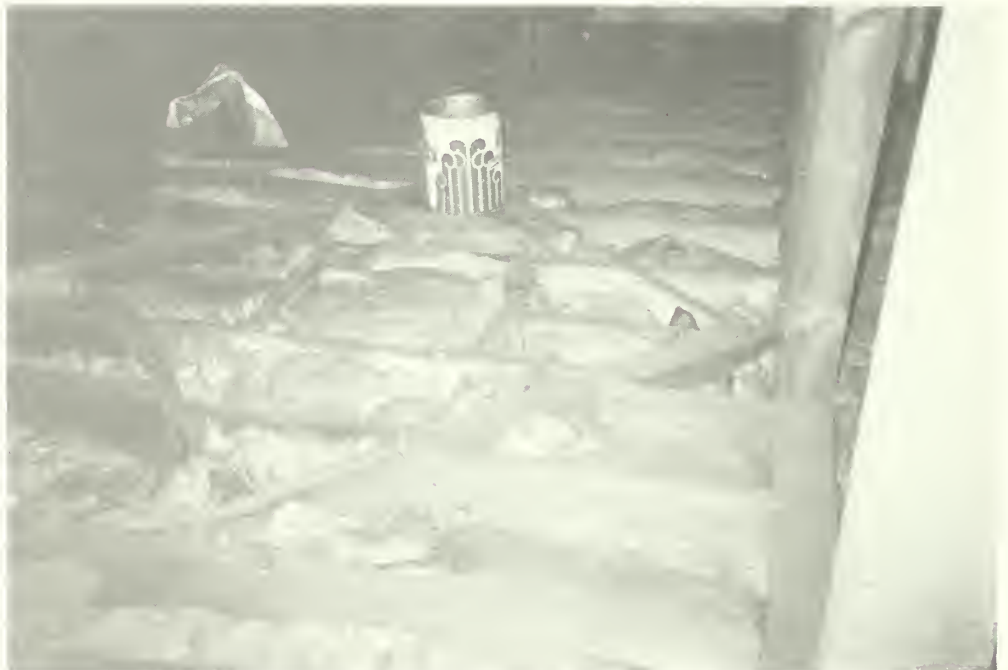
Photo E-31a View of third floor ceiling framing from attic showing framing for ventilator.
Clubhouse 1992

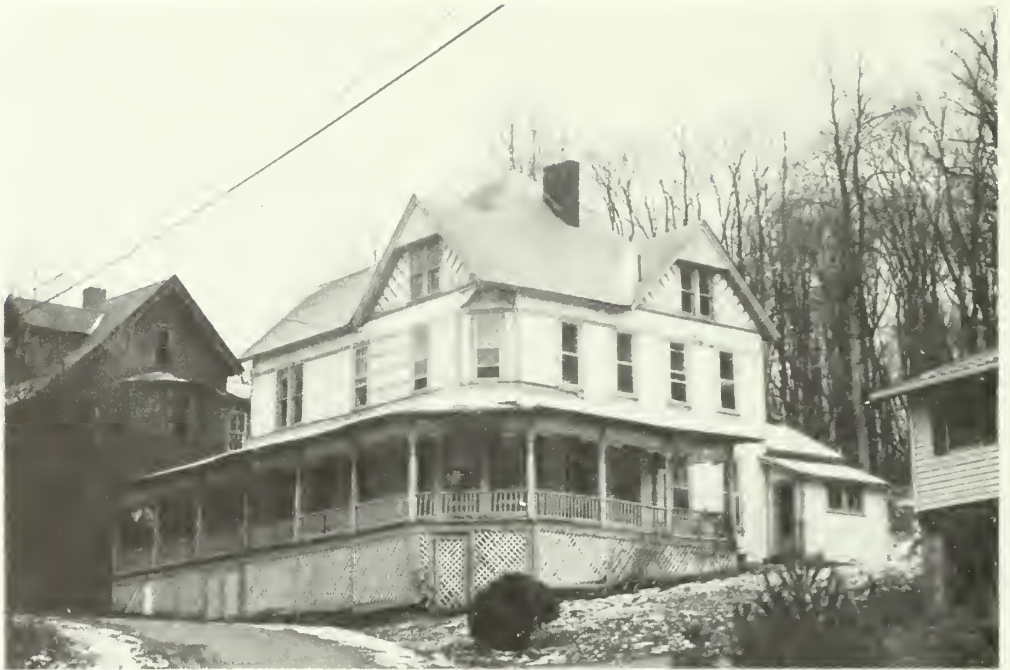
The exterior of the building remains much as it appeared originally. (Photos E-32 through E-35) Alterations to the exterior are limited to three window changes, the addition of a door, relocation of the porch steps, removal of the shutters, and removal of an eyelid dormer on the east roof slope. Although it has been suggested that the one story kitchen wing at the rear of the house is a later addition to the house,³ no physical evidence exists to support the theory. A small rectangular concrete foundation is located at the uphill western edge of the site opposite the rear entrance on the west facade. Local residents recall the concrete foundations for outhouses installed by the mining company.⁴

Photo E-32 View of east and north elevations.
Brown Cottage 1992

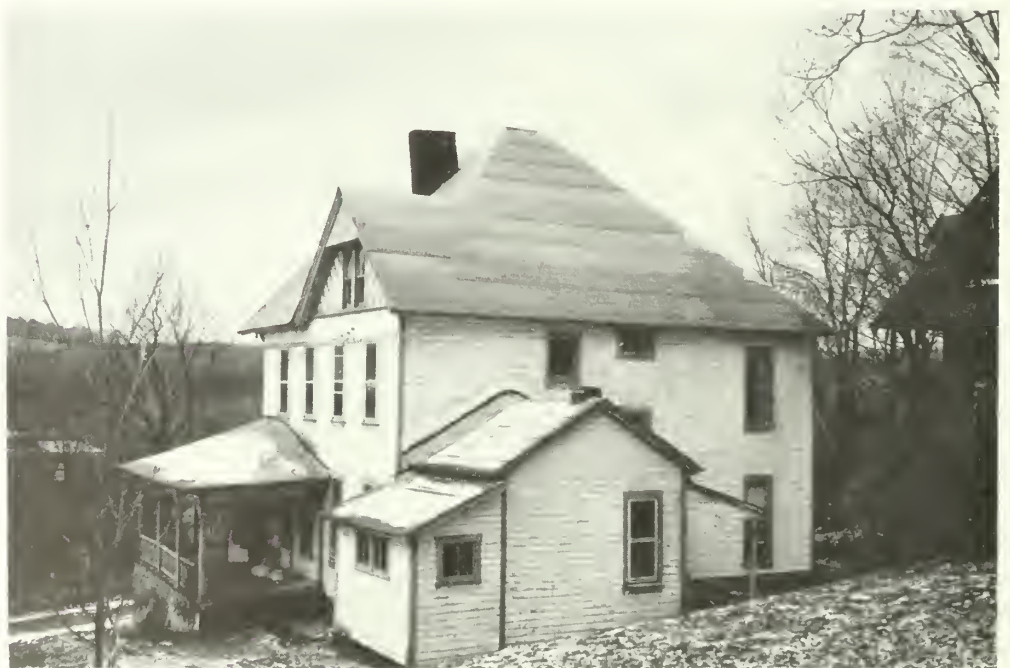
Photo E-33 View of north and west elevations.
Brown Cottage 1992

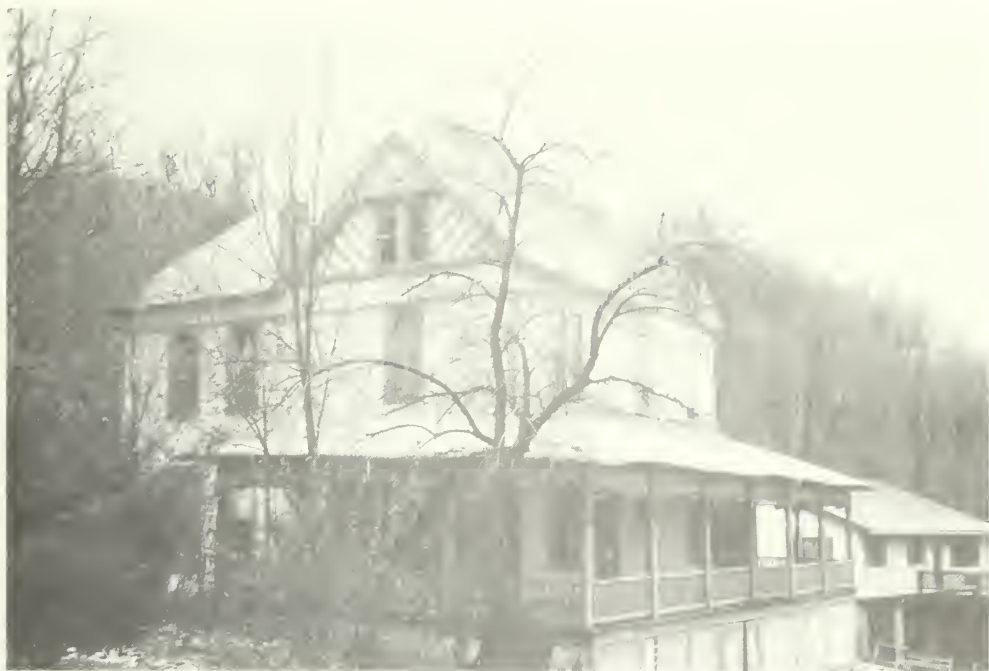
E-34 View of south and east elevations.
Brown Cottage 1992

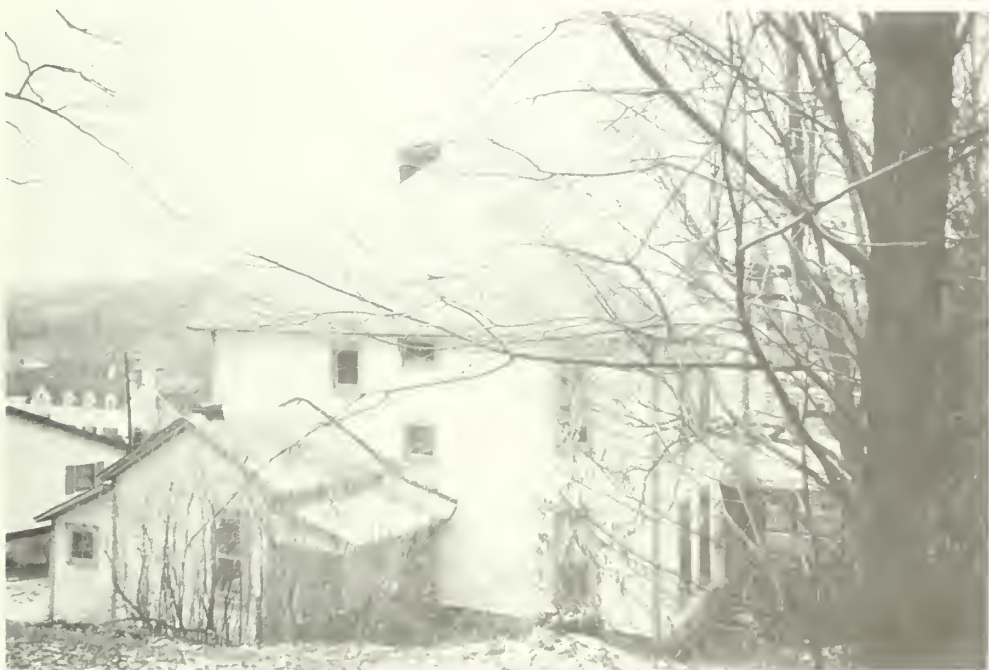
E-35 View of west elevation. Note foreshortened windows on elevation of main building.
Brown Cottage 1992

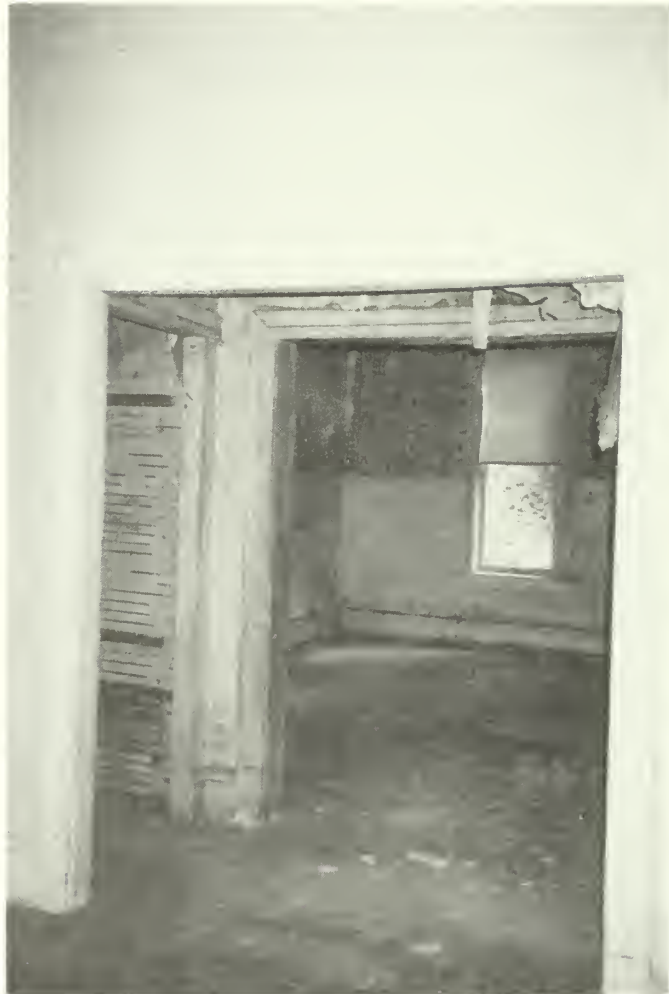
Photo E-39 Looking southwest at altered area between rooms
105 and 103.
Brown Cottage 1992

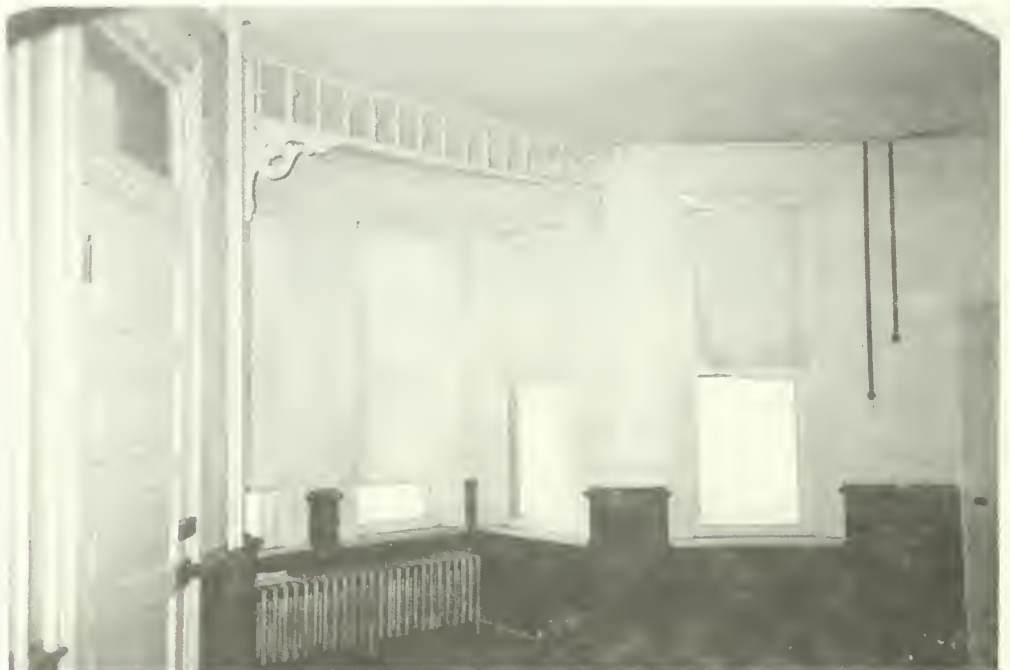
Photo E-42 Northeast bay with decorative wood bracket in room 106.
Brown Cottage 1992

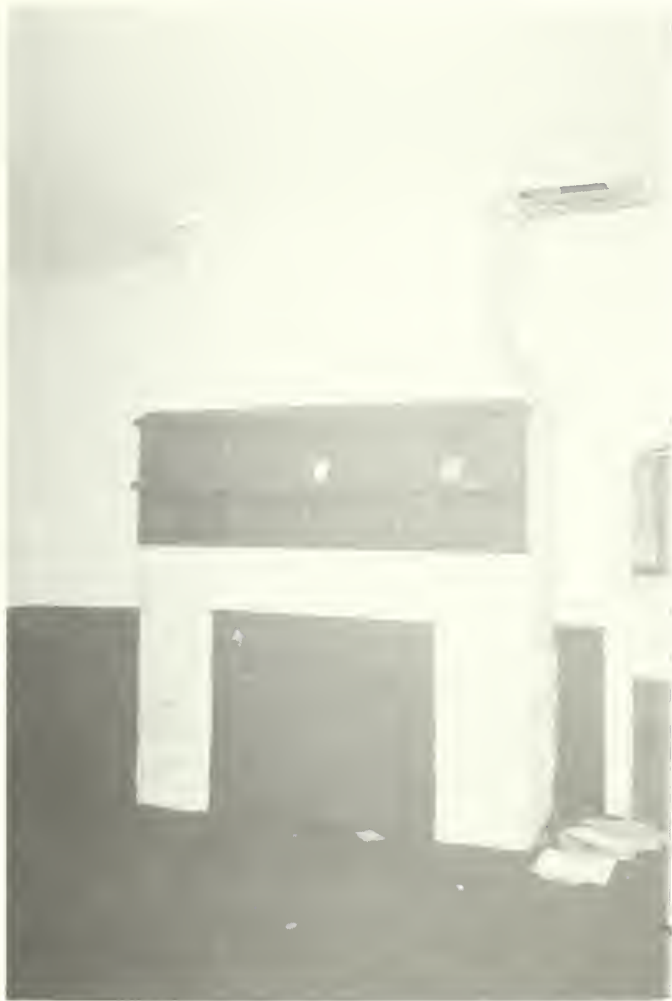
Photo E-43 Chimney and fireplace on west wall of room 106.
Brown Cottage 1992

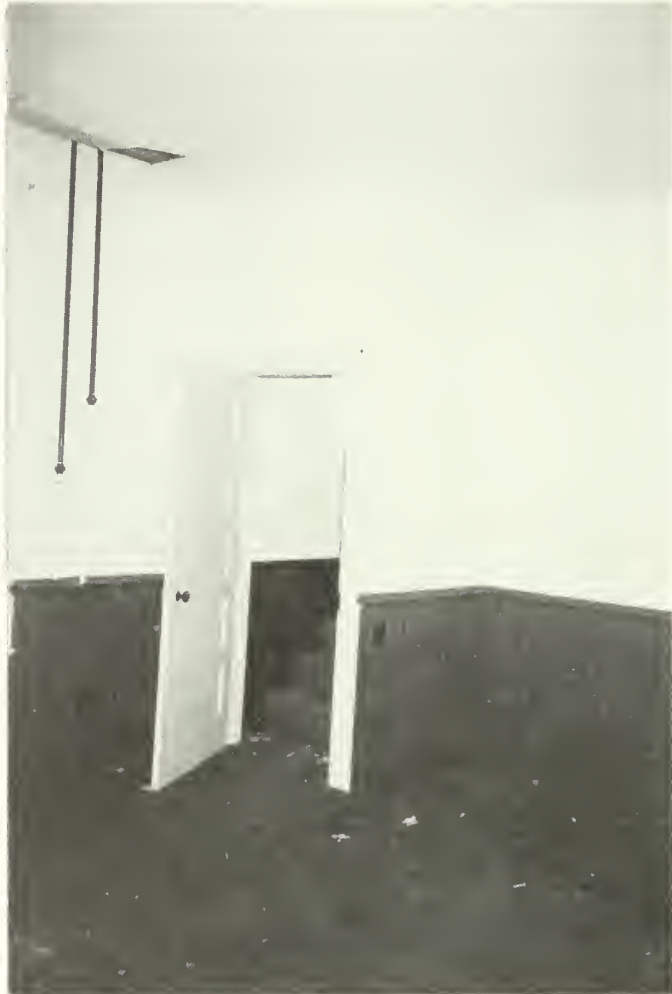
Photo E-44 Southeast corner of room 106 showing enclosed stair added during the Mining Company Era. Brown Cottage 1992

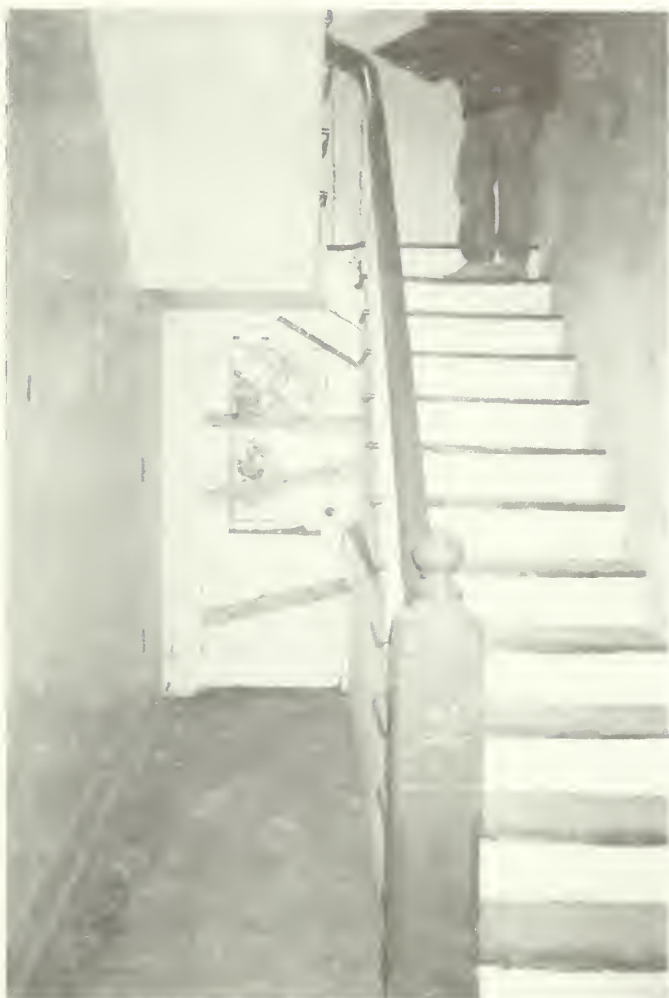
Photo E-45 West view of stair and hall, room 100.
Brown Cottage 1992

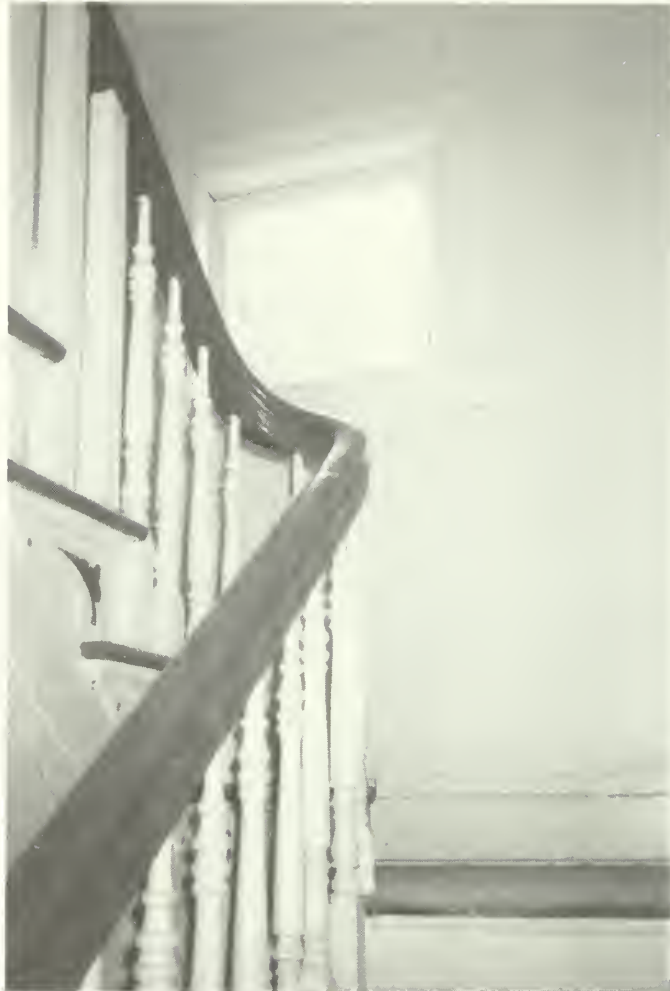
Photo E-46 Detail of change in spindle style in stair at landing between first and second floors in room 100. Brown Cottage 1992

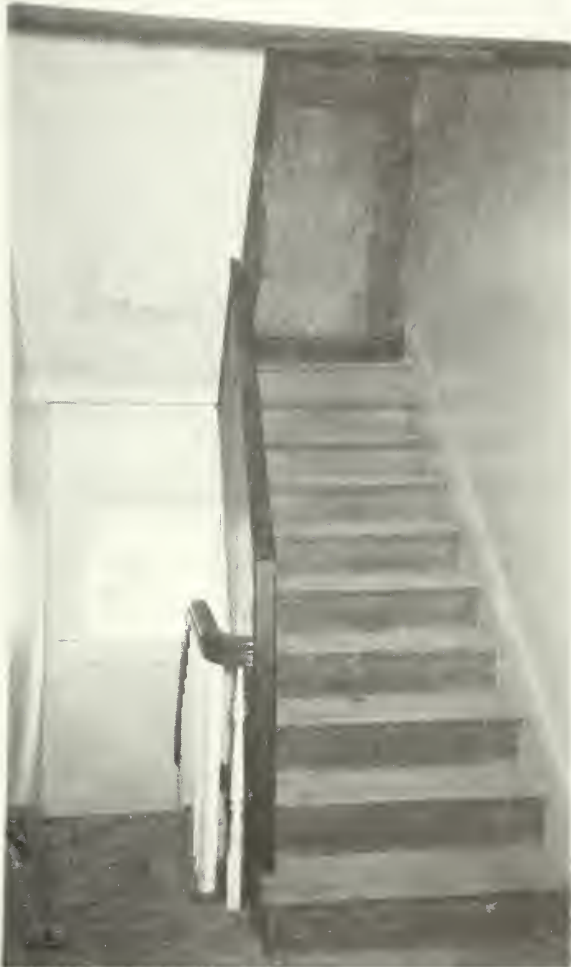
Photo E-47 Second floor view of the main stair from the hall
(room 200), looking west.
Brown Cottage 1992
